Trouble shooting Pac Food's VS305 vacuum sealer: Lid Not Releasing

Issue – Lid not releasing:

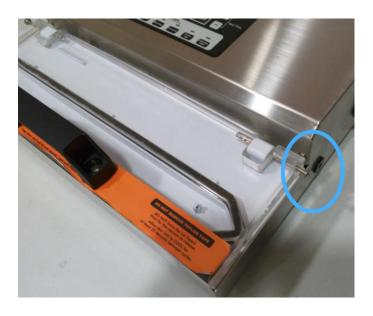
Check the extraction port is clear and not blocked

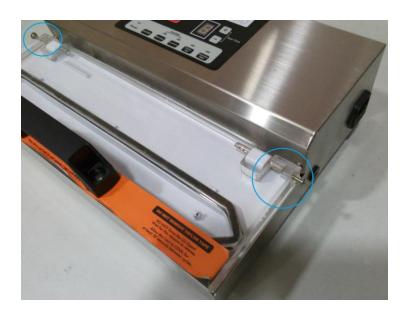
Remove screws at either end of lid

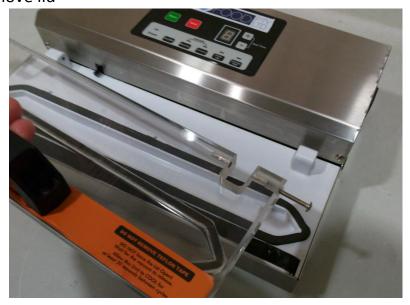
Remove lid

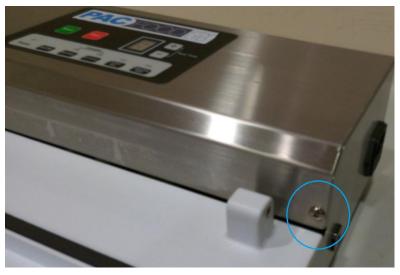
Remove two screws at the front

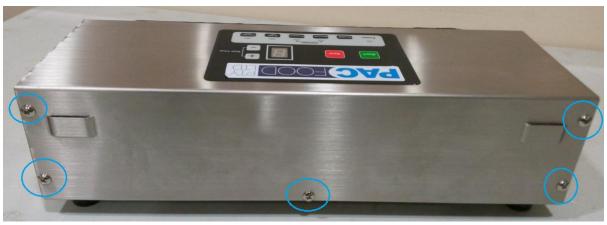
Remove 5 screws at the rear

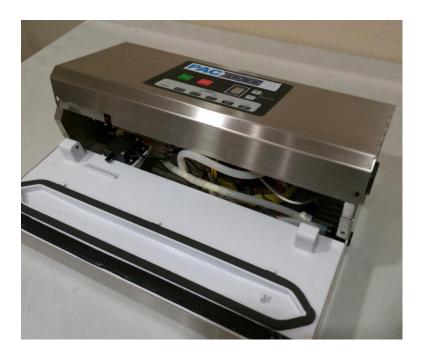
Lift top housing cover carefully

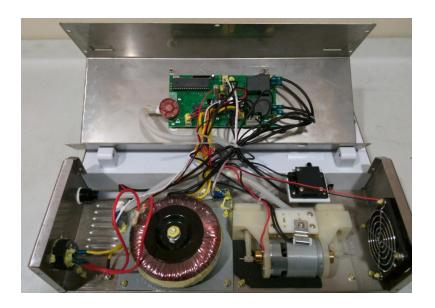
Lift cover; please be aware of cables connected to control board

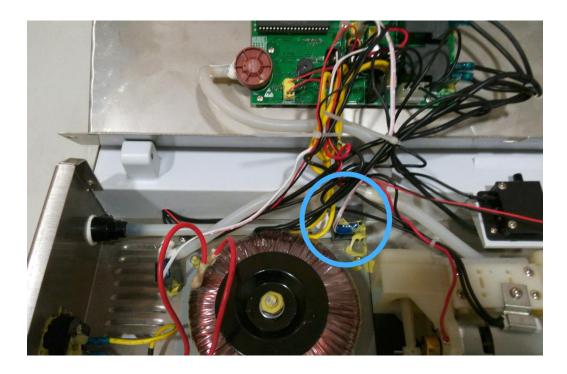
The large valve controlling sealing and releasing may need to be replaced

The large valve circled below may need to be checked or replaced

Replace the large valve and follow the above steps to re-assemble the machine

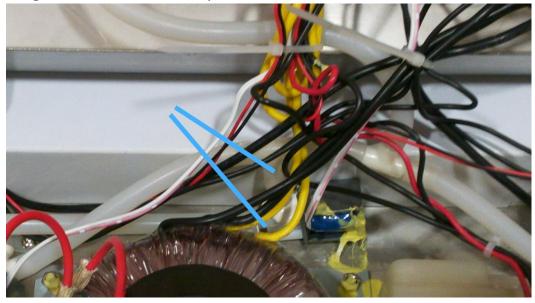
If the large valve needs to be replaced remove hoses indicated below

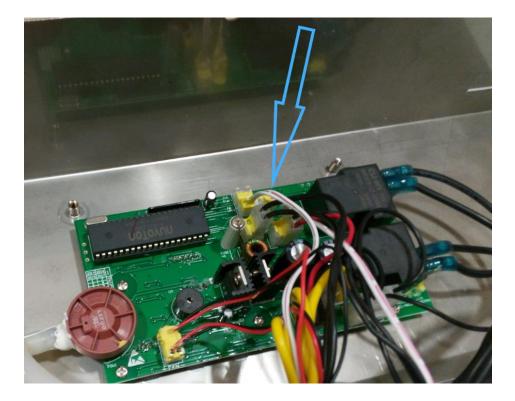
Remove connector indicated on control board.

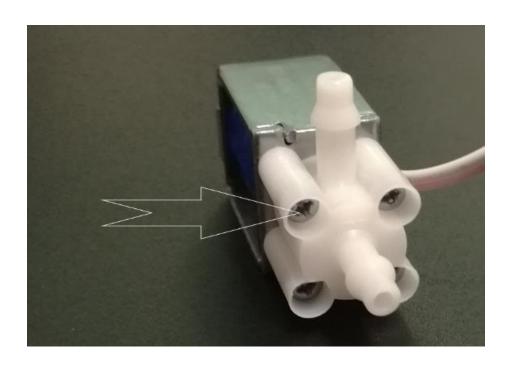
In emergency cases if the machine is required to be used urgently the large valve may be cleaned out as below: Remove the 4 Phillips Head screws:

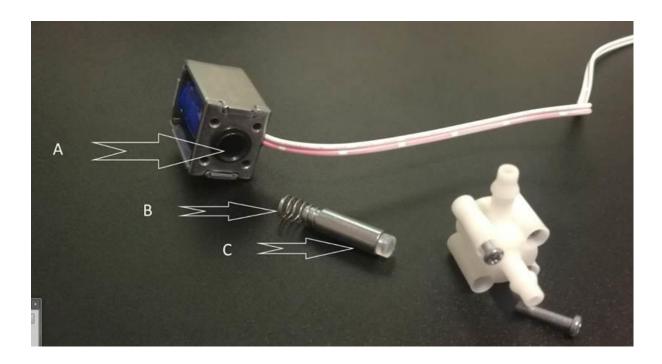
Wipe down / clean and then lubricate with CRC or WD40: (Don't use silicon spray it may swell the seals)

A: Cavity B: Spring

C: Rod

Then re-install.
