Trouble shooting Pac Food's VS305 vacuum sealer: Vacuuming issues

Check Hoses and Small Valve Replacement Procedures

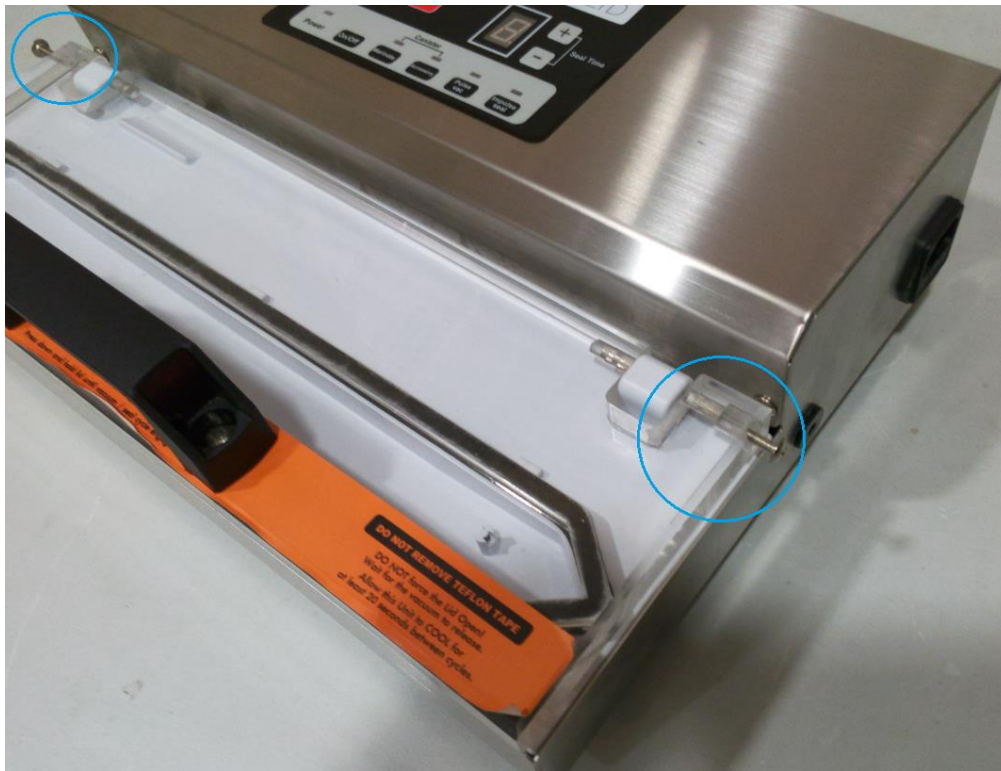
Remove screws at either end of lid

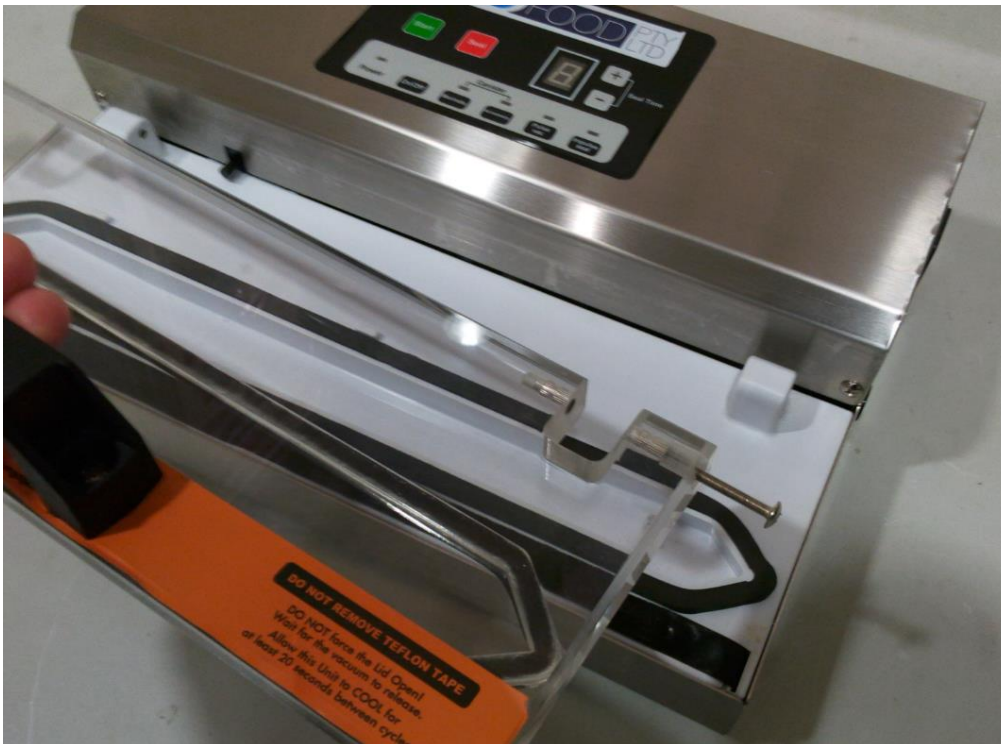
Remove lid

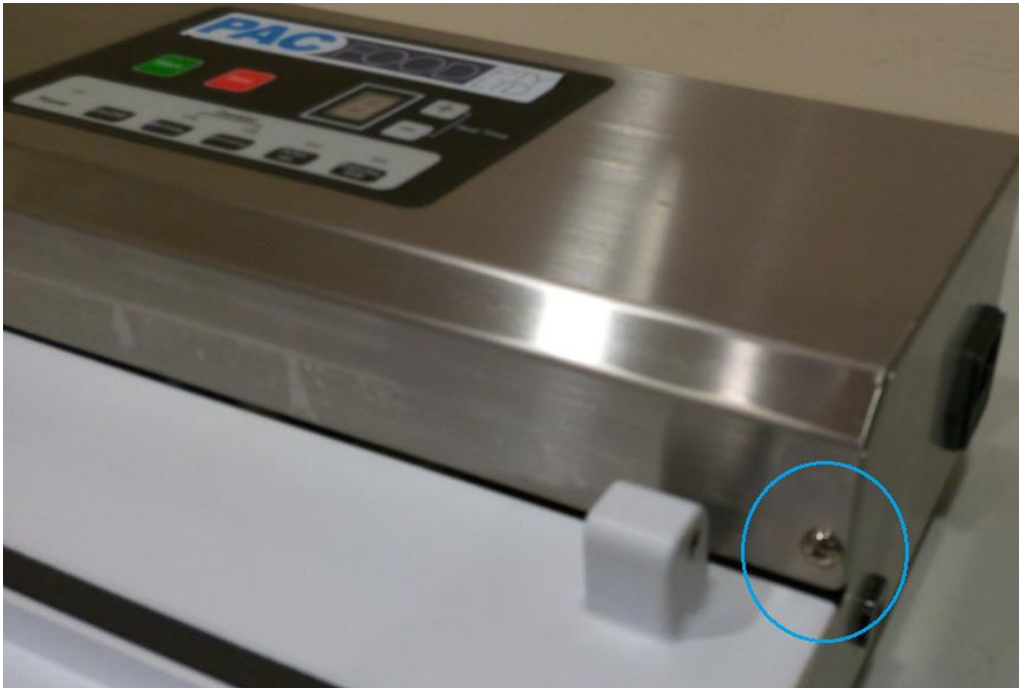
Remove two screws at the front

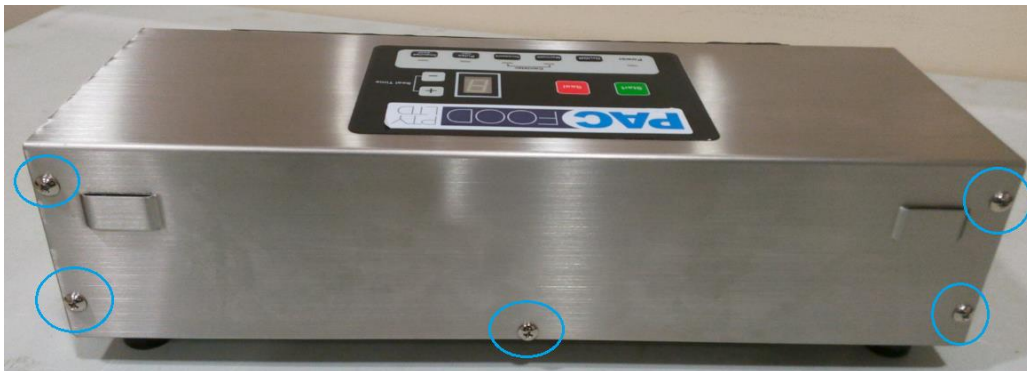
Remove 5 screws at the rear

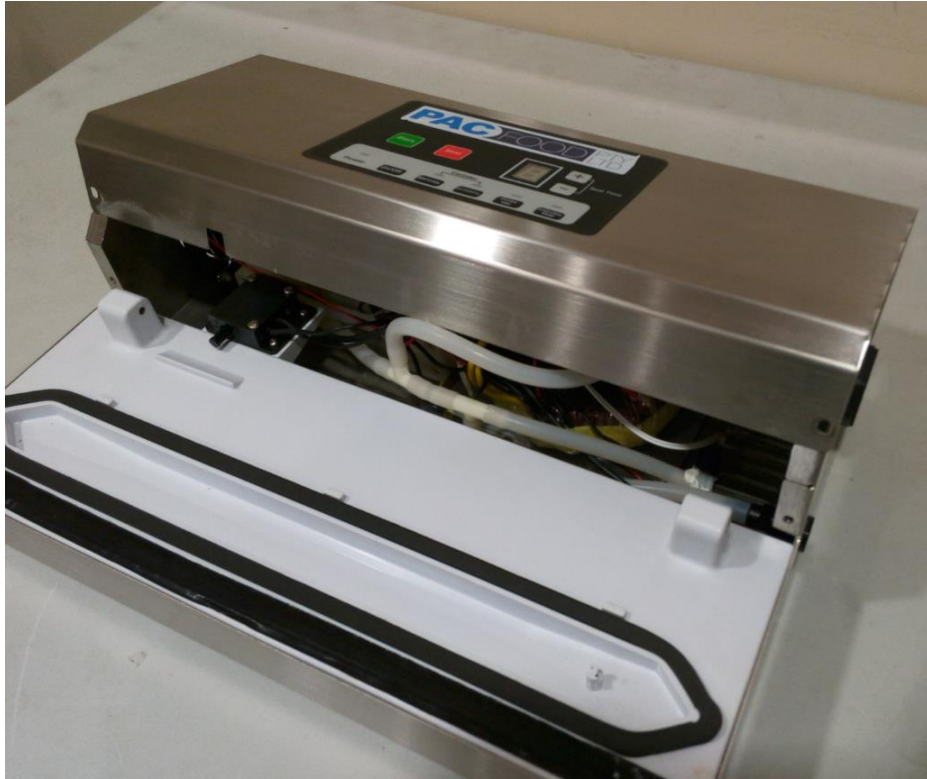
Lift top housing cover carefully

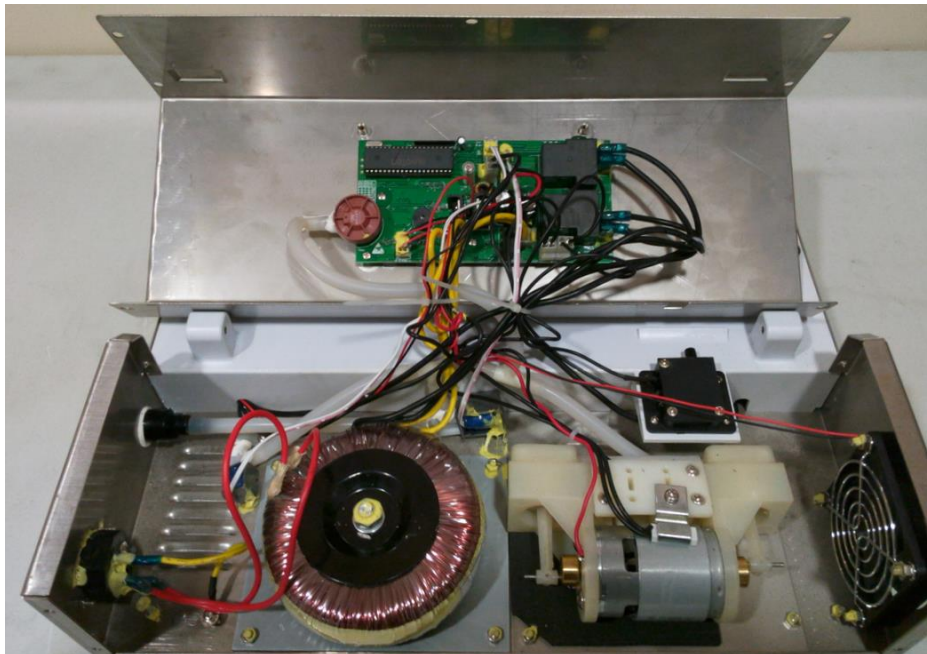
Lift cover; please be aware of cables connected to control board

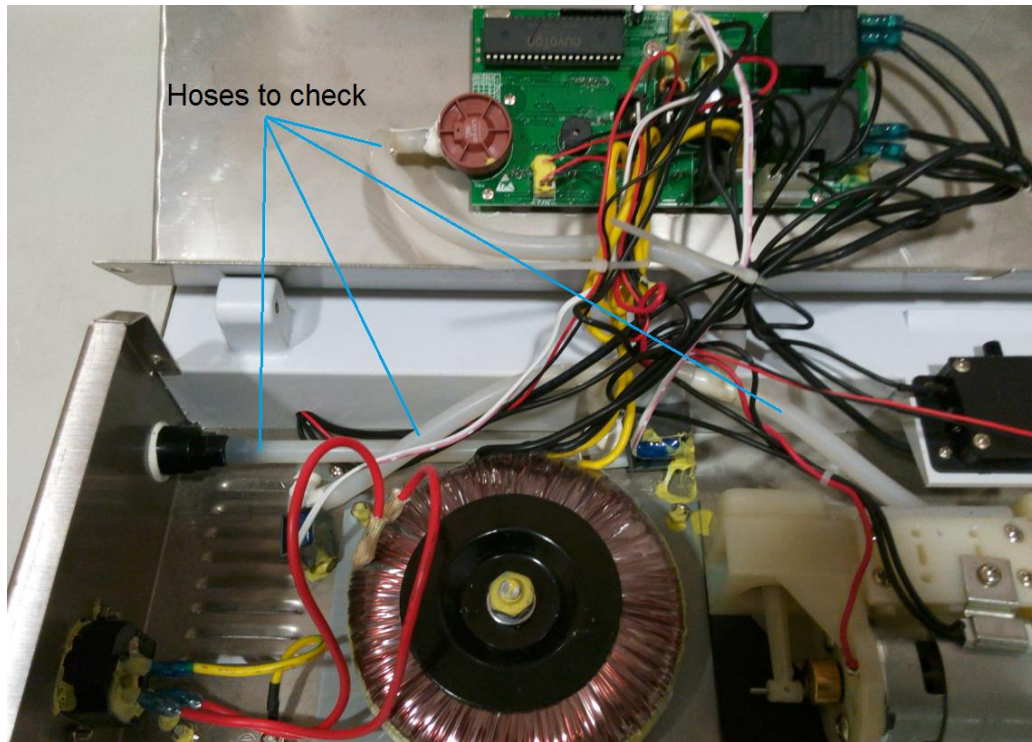
Check all hoses and connections. If there are any hoses that are disconnected please re-attach. If any connectors are damaged please contact Pac Food

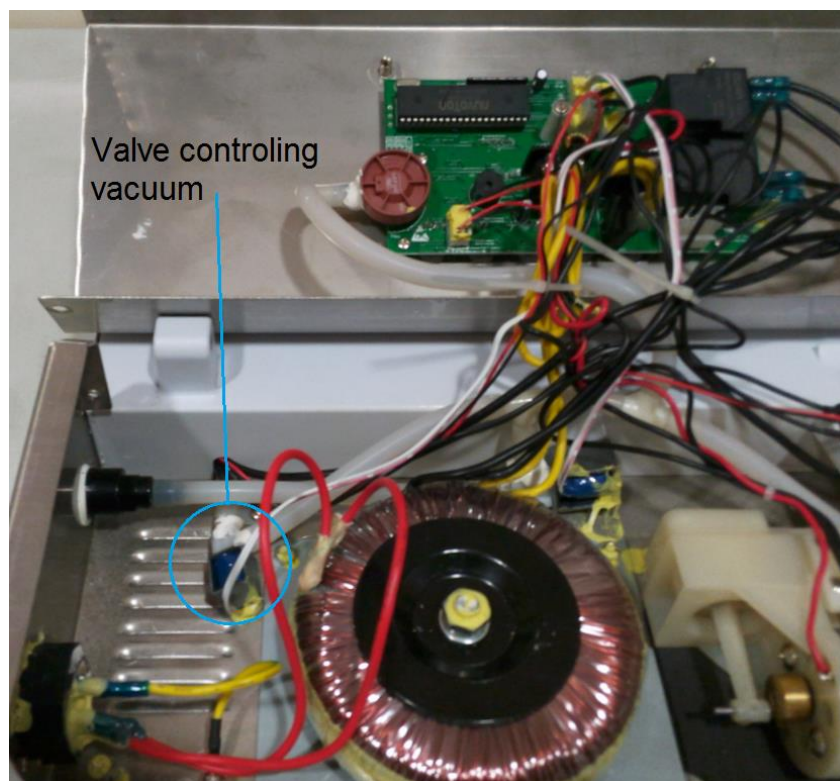
If all hoses are intact the small valve circled below may need to be checked

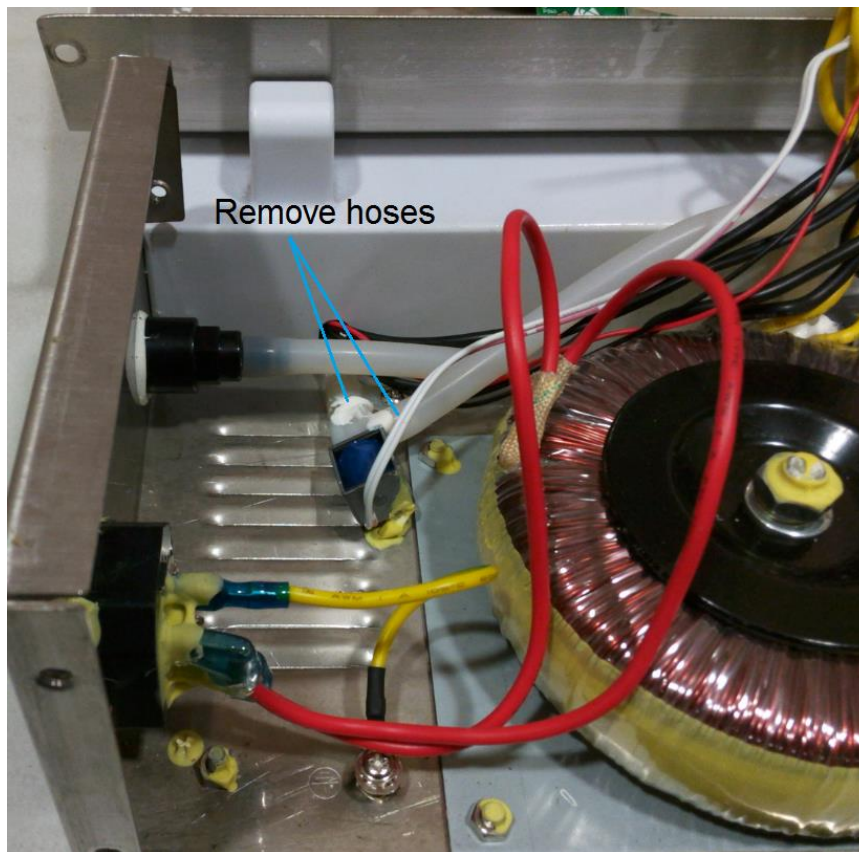
If the small valve needs to be replaced remove hoses indicated below

Replace the small valve and follow above steps to re-assemble vacuum sealer.

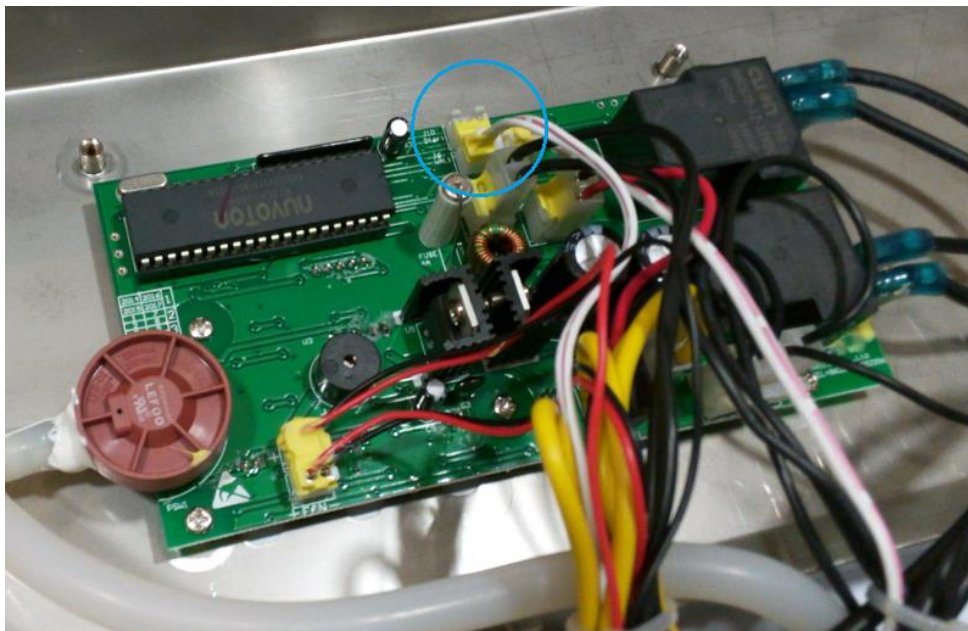
Remove connector indicated on control board.

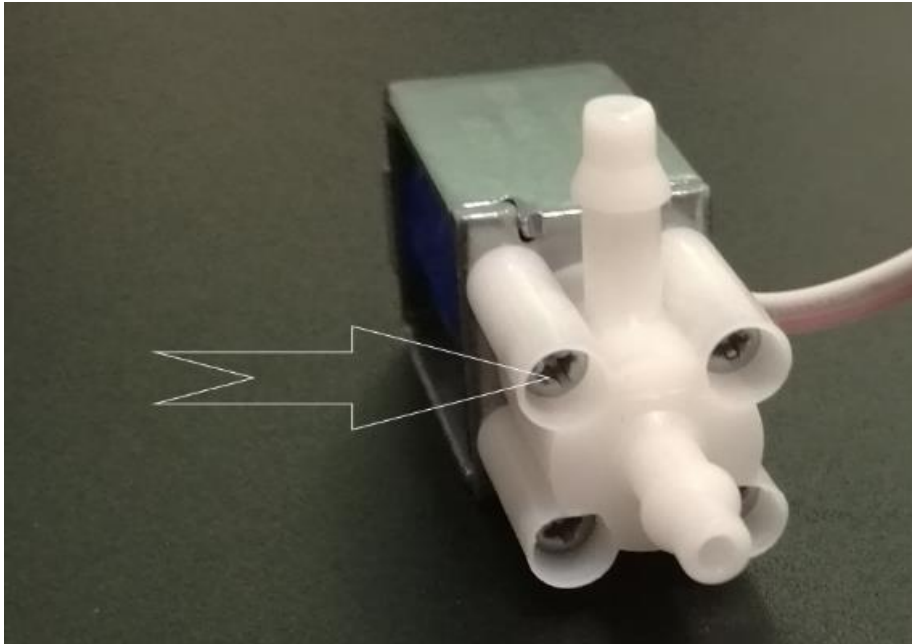
Remove the 2 Phillips Head screws:

In emergency cases if the machine is required to be used urgently the small valve may be cleaned out as below:

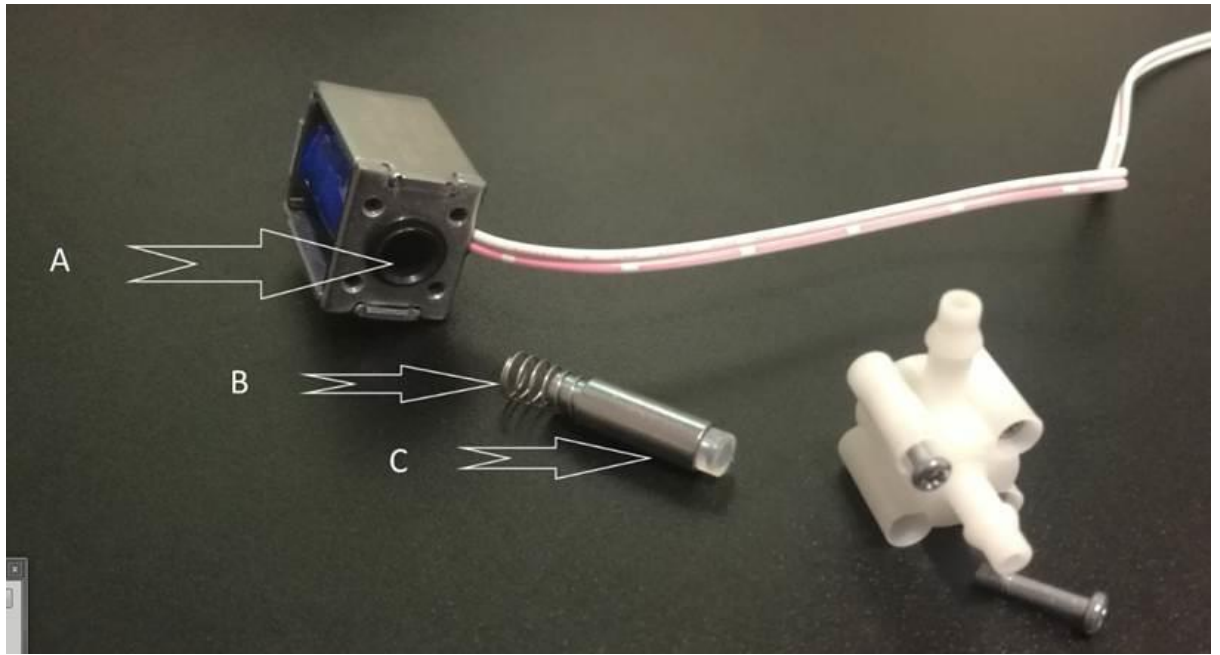
Wipe down / clean and then lubricate with CRC or WD40: (Don't use silicon spray it may swell the seals)

A: Cavity

B: Spring

C: Rod

Then re-install.
